# Manhole Inspection Summary

Manhole # S27EE\_036MH

Insp Date: **11/20/07 1:44 PM**

**Location** Address: **500 MOSHER ST**

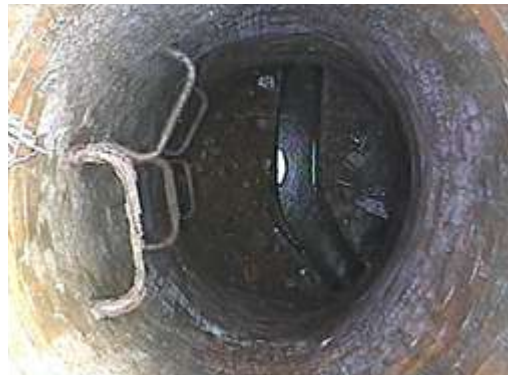
Defect 2

**Steps** Count: **6** Missing: **1** ☒ **Corroded**

STEPS CORRODED

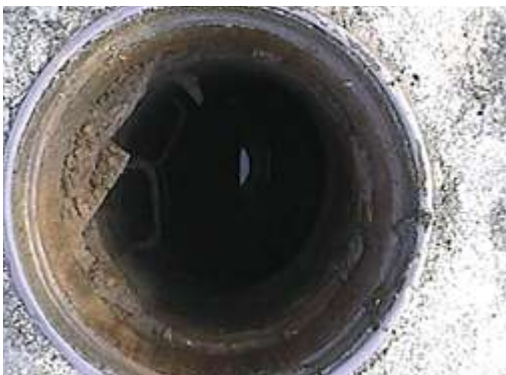
Defect 1

Condition: ☐ Sound ☐ Cracked ☐ Root Intrusion ☐ Loose Brick ☒ **Deteriorated**

CHIMNEY DETERIORATED

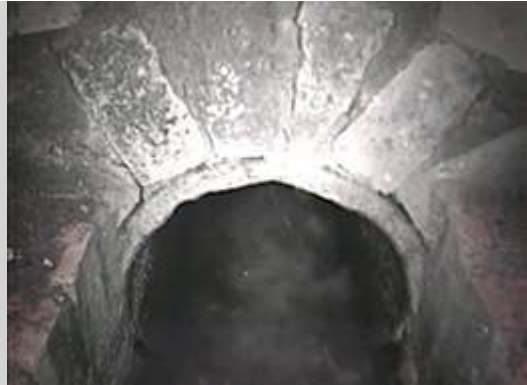
12 O'Clock Outflow

8 in. Circular Gravity Sewer  
Pipe Out @ 12 O'Clock

Invert Depth: **10.14** (ft.) Flow Characteristics: **Slow**

Infiltration: **None** Pipe Seal Cond: **Sound**

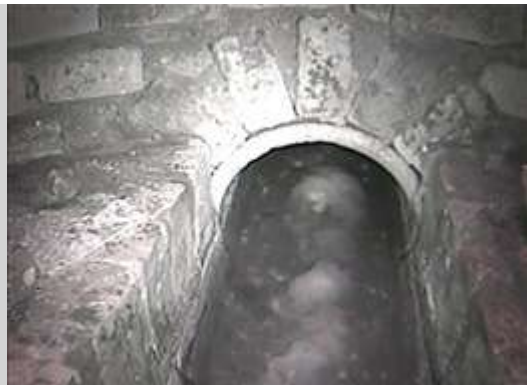
6 O'Clock Inflow

8 in. Circular Gravity Sewer  
Pipe In @ 6 O'Clock

Invert Depth: **10.12** (ft.) Flow Characteristics: **Slow**

Infiltration: **None** Pipe Seal Cond: **Sound**
